| Drawing ID | |
|---|--|
| FS-TSX | |

Duplex 2205 Stainless Steel
 > Glass Fixing System

> Smarter Side Fix Spigot

Product – Smarter Spigot Tested By Azuma Design Pty Ltd

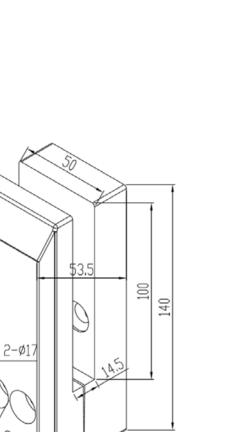
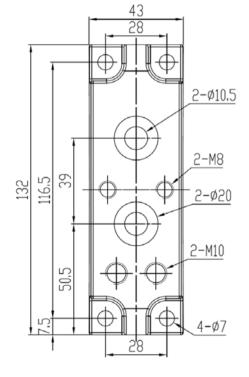
Suitable for 12-13.52mm Glass

108

21.5

Ø6

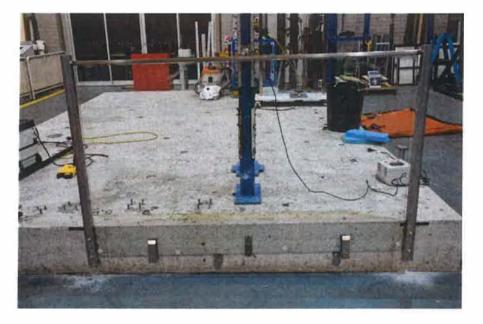
| Model No./Name | Smarter Spigot |
|---|---|
| Test Sample Description | 13.52 mm (6/1.52/6 mm) toughened laminated glass 1900 x 1200 mm. Glass is held by 2 x stainless steel spigots face mounted to the side of a concrete slab spaced at 1200 mm. Spigots are fixed to the concrete with M6 x 70 mm Hex Bolt and Hex drive screws on the mounting plate. A second piece is then attached to the mounting plate to make one half, the other half is connected to clamp the glass between using 2 x M8 x 20 mm and 2 x M10 x 45 mm Cap Screws. A capping rail is silicone to the top of the glass and attached to 50 x 50 x 1300 mm stainless steel posts with a 30 mm gap to the glass. The posts are secured to the side of the concrete slab by M8 x 150 mm bolts spaced at 120 mm apart and 65 mm from the bottom of the post. Glass fits 45 mm above the bottom of the spigot with 105 mm engagement. |

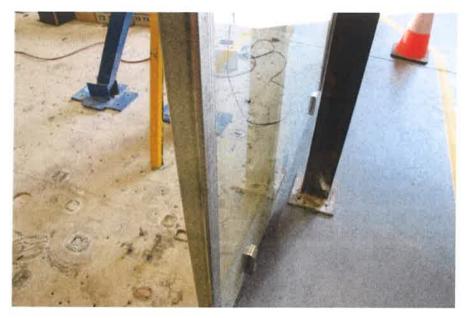
<u>CLIENT – TCT GROUP</u> <u>PRODUCT – SMARTER SPIGOT</u>

Model No./Name Smarter Spigot Customer TCT Group Address 1 Harbord St, Clyde NSW 2142 Azuma Testing Number AZT0264.23 Date of Test 13/07/2023 Yes, capping rail fixed at each end with a bracket and M8 Structural Connection screw and nut on a stainless-steel post to simulate a wall connection. 12 mm toughened glass 1800 x 1200 mm. Glass is held by 2 x stainless steel spigots face mounted to the side of a concrete slab spaced at 1200 mm. Spigots are fixed to the concrete with M6 x 70 mm Hex Bolt and Hex drive screws on the mounting plate. A second piece is then attached to the mounting plate to make one half, the other half is connected to clamp the glass Test Sample Description between using 2 x M8 x 20 mm and 2 x M10 x 45 mm Cap Screws. A capping rail is silicone to the top of the glass and attached to 50 x 50 x 1300 mm stainless steel posts with a 30 mm gap to the glass. The posts are secured to the side of the concrete slab by M8 x 150 mm bolts spaced at 120 mm apart and 65 mm from the bottom of the post. Glass fits 45 mm above the bottom of the spigot with 105 mm engagement.
